DOE/ID-10938⁸
August 2001

**SITE 029 TRACK 1
DECISION DOCUMENTATION
PACKAGE, OU 10-08**

**DECISION DOCUMENTATION PACKAGE
COVER SHEET****Prepared in accordance with****TRACK 1 SITES:
GUIDANCE FOR ASSESSING
LOW PROBABILITY HAZARD SITES
AT THE INEEL****Site Description:** Asphalt Near Main Guard Gate**Site ID:** 029**Operable Unit:** 10-08**Waste Area Group:** 10**I. Summary – Physical Description of the Site:**

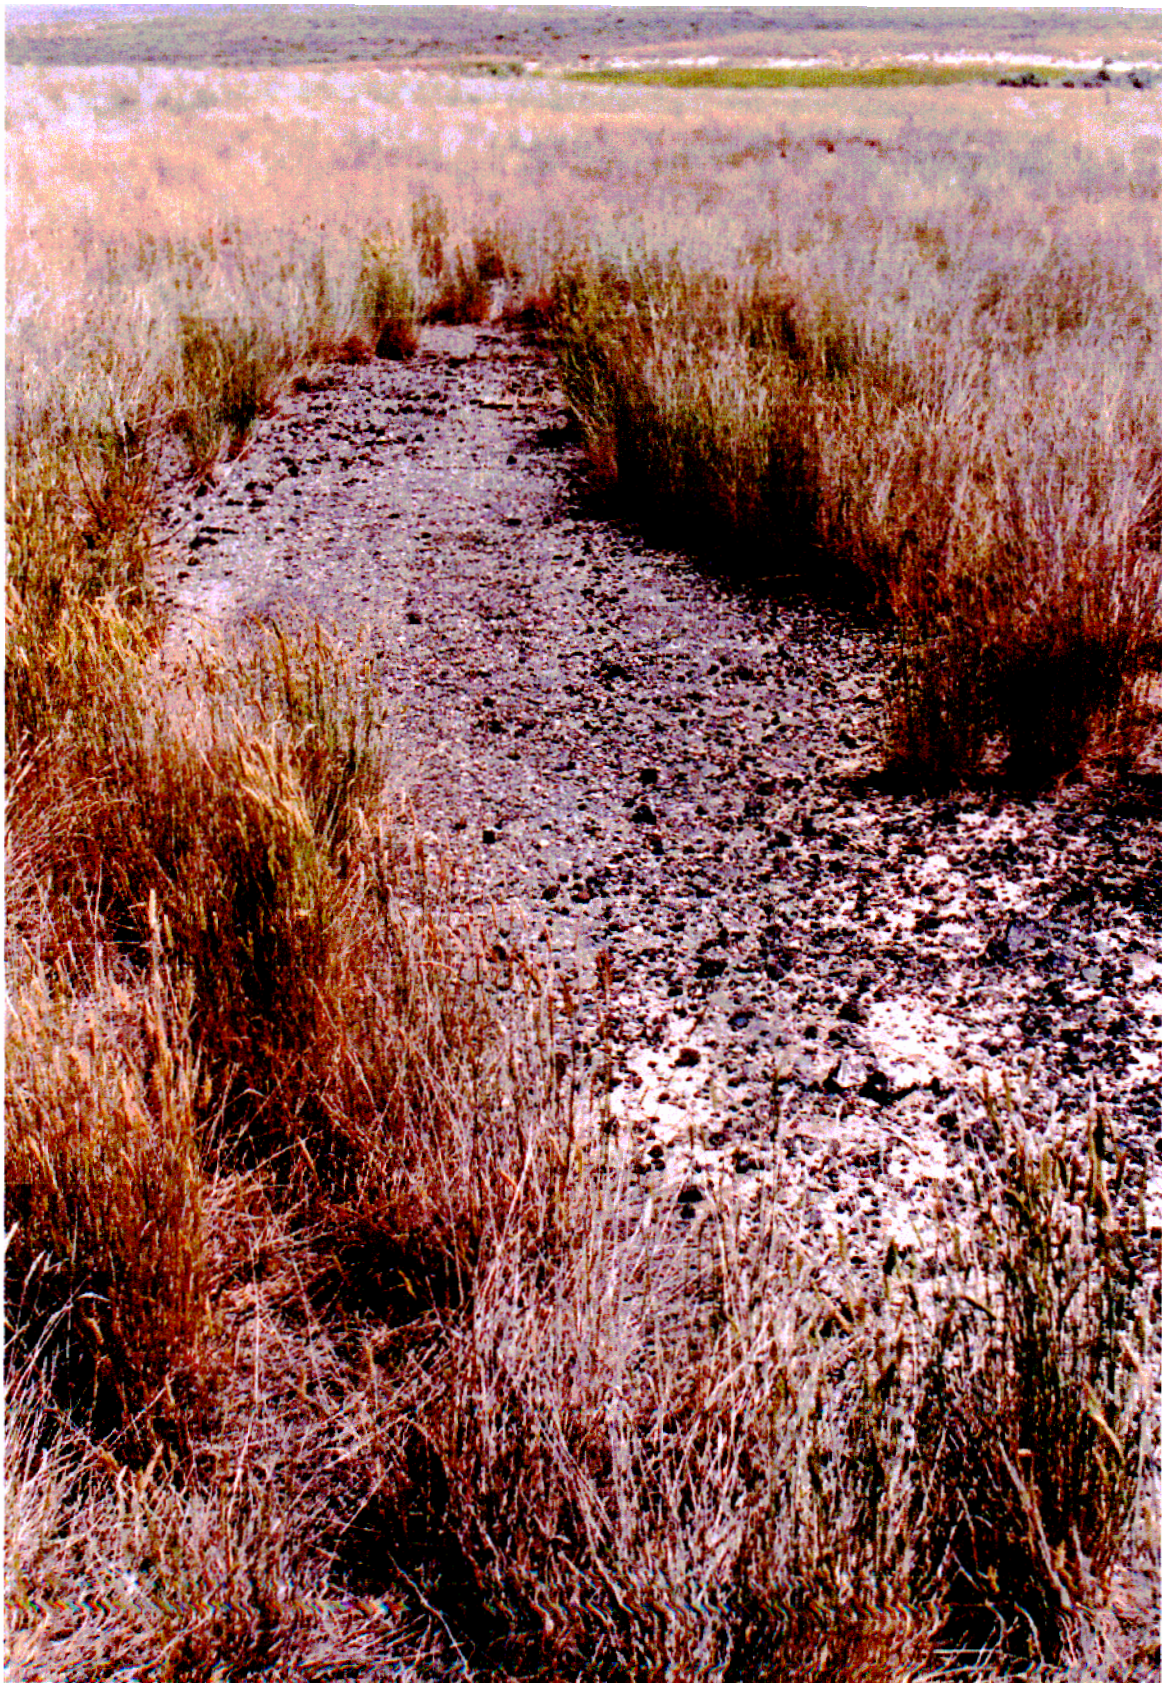
Site: 029 Asphalt Near Main Guard Gate
(PN99-0424-1-21)

Early investigations revealed that Site 029 included several large areas of broken-up asphalt. The total estimated size of the area is approximately 5 ft wide x 30 ft long x 0.083 ft deep. Because of the location of the site, it is likely that the asphalt was left over from paving operations near the Main Guard Gate. It appeared the excess asphalt was driven a short distance away and discarded near the roadside.

It is recommended that this newly identified site be classified as No Further Action. Field investigations and interviews indicate it is highly unlikely that hazardous or radioactive materials were generated or disposed of at this site. There is nothing present at this site that would indicate evidence of contaminant migration, or historical or threatened release of hazardous substances, pollutants or contaminants. Central Facilities Area (CFA) is the closest INEEL facility, located approximately 3 miles northwest of the site. The site formerly consisted of several areas of discarded asphalt in close proximity to Highway 20 and the INEEL Main Guard Gate intersection. A new off-ramp was installed in 2000 over the area that formerly contained the asphalt. The asphalt chunks, soil, native grasses and sagebrush were removed to prepare the area for grading and paving. The asphalt was properly discarded into the INEEL landfill.
